# **Almaty Airport Expansion - VIP Terminal Building**

Heritage Statement

June 2022

JSC Almaty International  
Airport

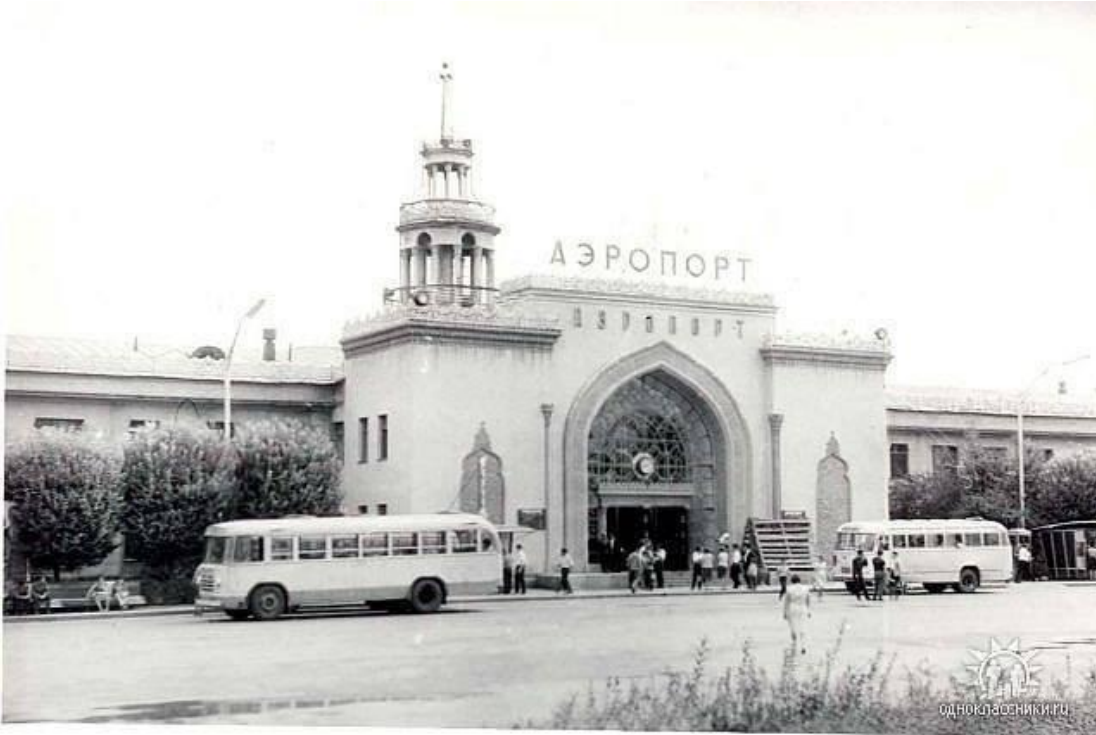
**Figure 5.1: The eastern elevation of the VIP Terminal Building in 1966, showing the building's central pishtaq and belvedere as well as elements of Kapanov's decoration added in 1957**

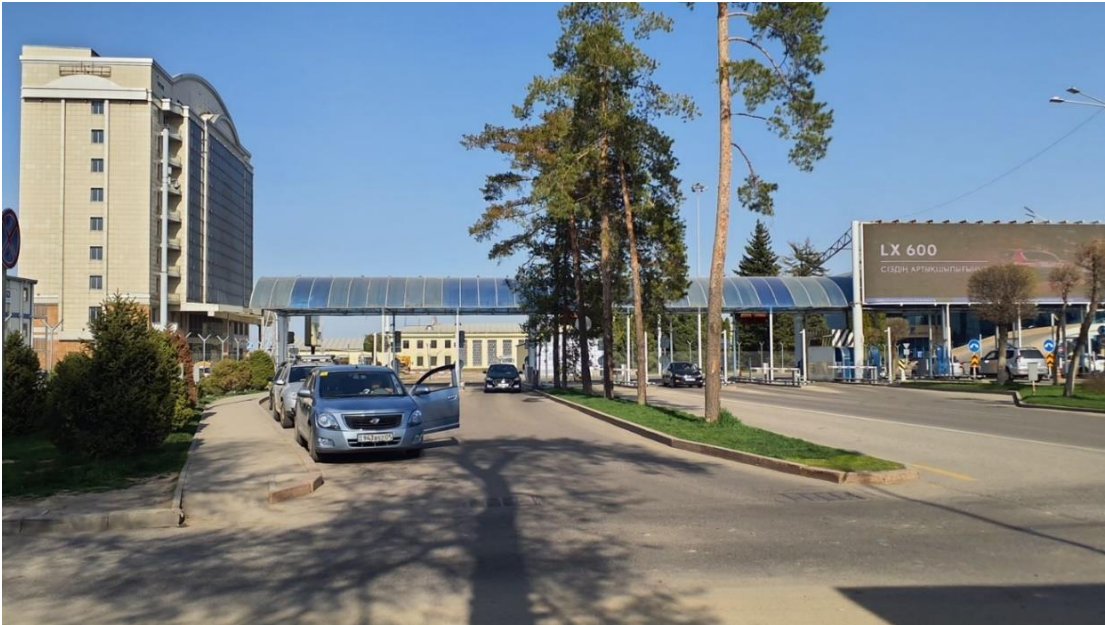
**Figure 5.3: Views east along Mailin Street towards the VIP Terminal Building which is framed by the canopies of barriers at the entrance to the airport**

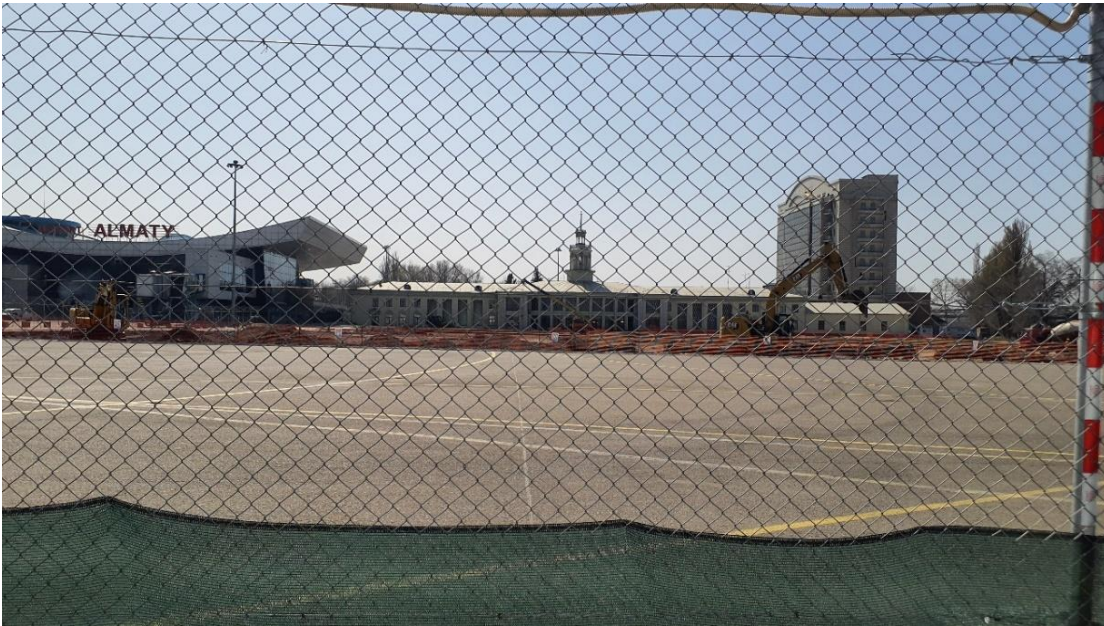
**Figure 5.5: Views towards the VIP Terminal Building from the apron**

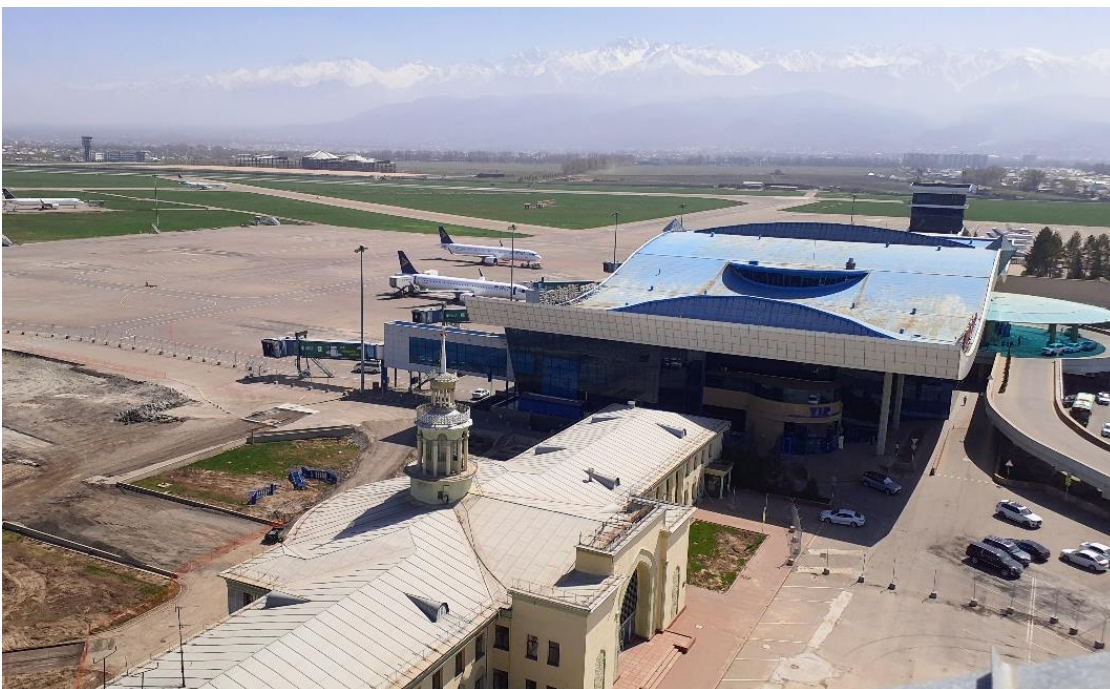
**Figure 5.6: Overhead view of VIP Terminal Building from the north showing relationship with the Main Terminal**

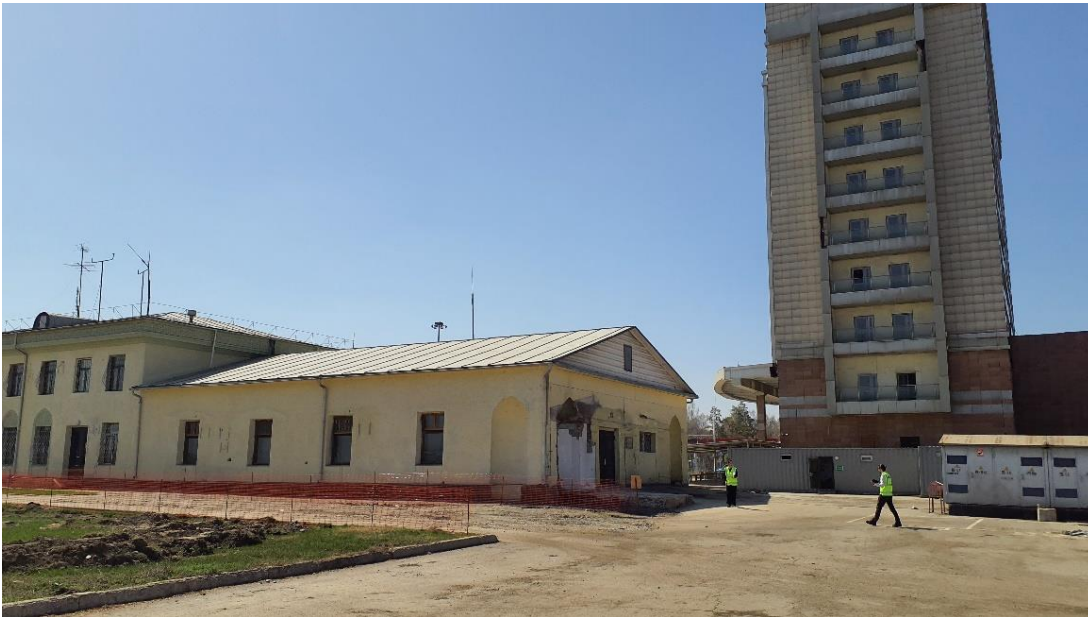
**Figure 5.7: View of the VIP Terminal Building, single storey extension and former hotel building from the east**

However, the loss of the loggia on the eastern elevation, alteration to the original fenestration and addition of the single storey extension to the north have altered this form, in particular the symmetry as viewed from each elevation and reduced the authenticity of the building. The interior of the building retains the central atrium, but has seen the balconies on the eastern elevation infilled. Otherwise, the interior has seen repeated renovations that have removed original decoration and changed the internal layout. The later design elements (which replaced the loggia) of the eastern elevation, the single storey extension and the entire interior lack authenticity and do not contribute to the building's cultural significance.

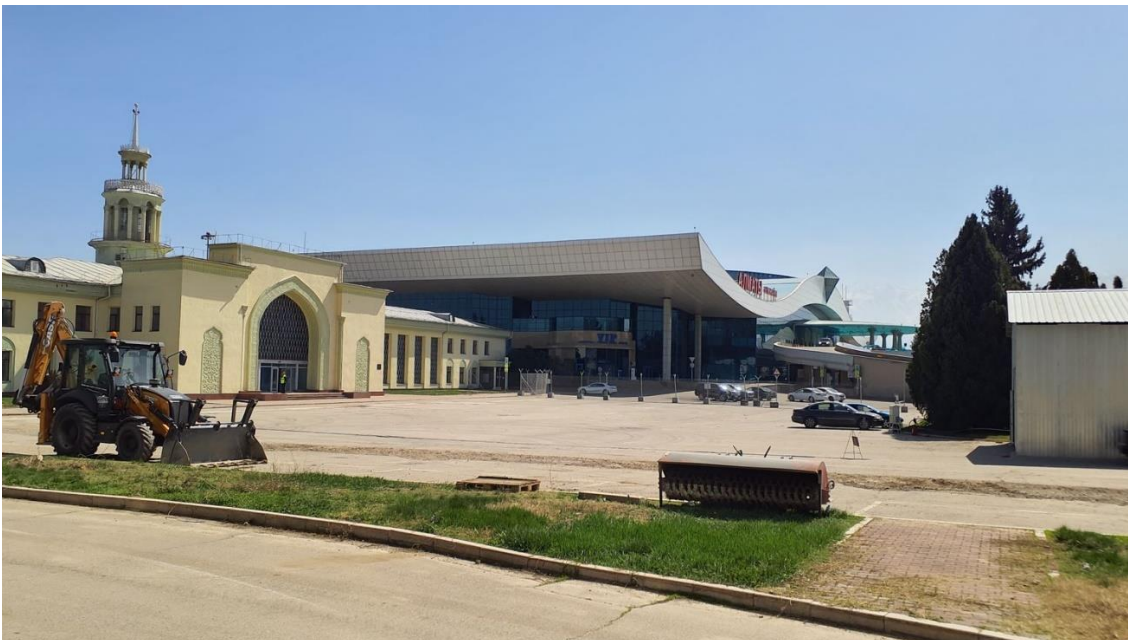
**Figure 5.8: The VIP Terminal Building viewed from the north-west, with the later terminal building overshadowing it in the centre of the image**

To the west the setting is formed by a small car park and remnants of a tree-lined garden. These are the surviving elements of the Building's historic context (Figure 5.8). This was visible in historic photographs as a neat tree-lined park in front of the Building. However, the trees are mature and screen the VIP Building from views further south on Mailin Street. Although the trees are an important original element of the building's historic context as a survival of the former gardens, they block views from Mailin Street. This element of the Building's historic spatial context has been further eroded by later airport developments. In particular temporary buildings and the entry/ exit barriers of the airport have reduced the visibility of the buildings on the vehicular, eastern approach to the airport terminal.

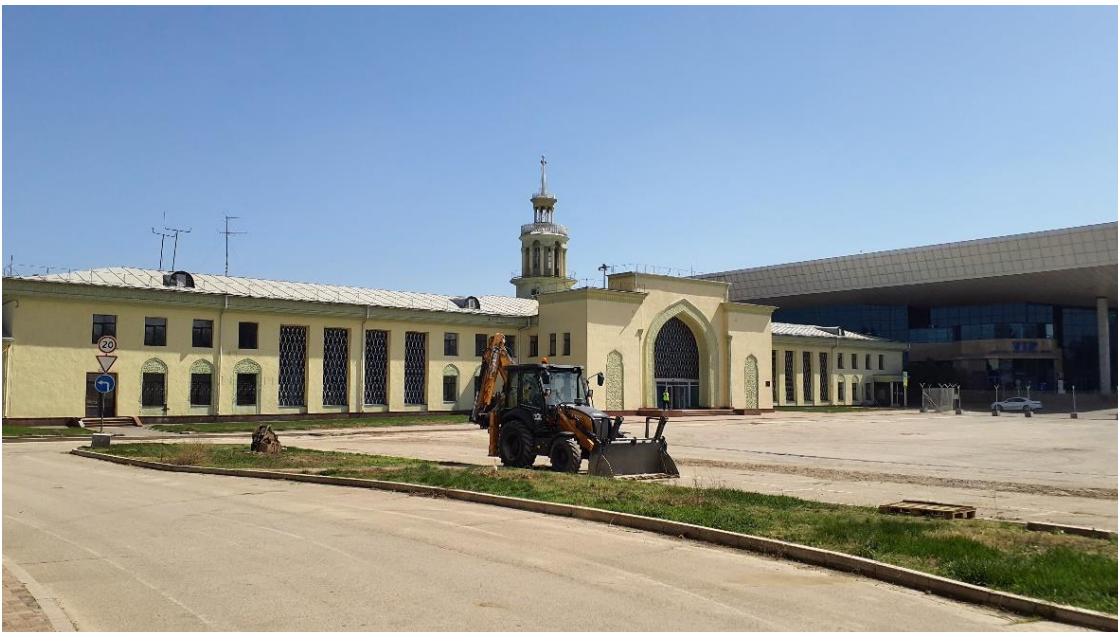
**Figure 5.9: The western elevation of the VIP Terminal Building**

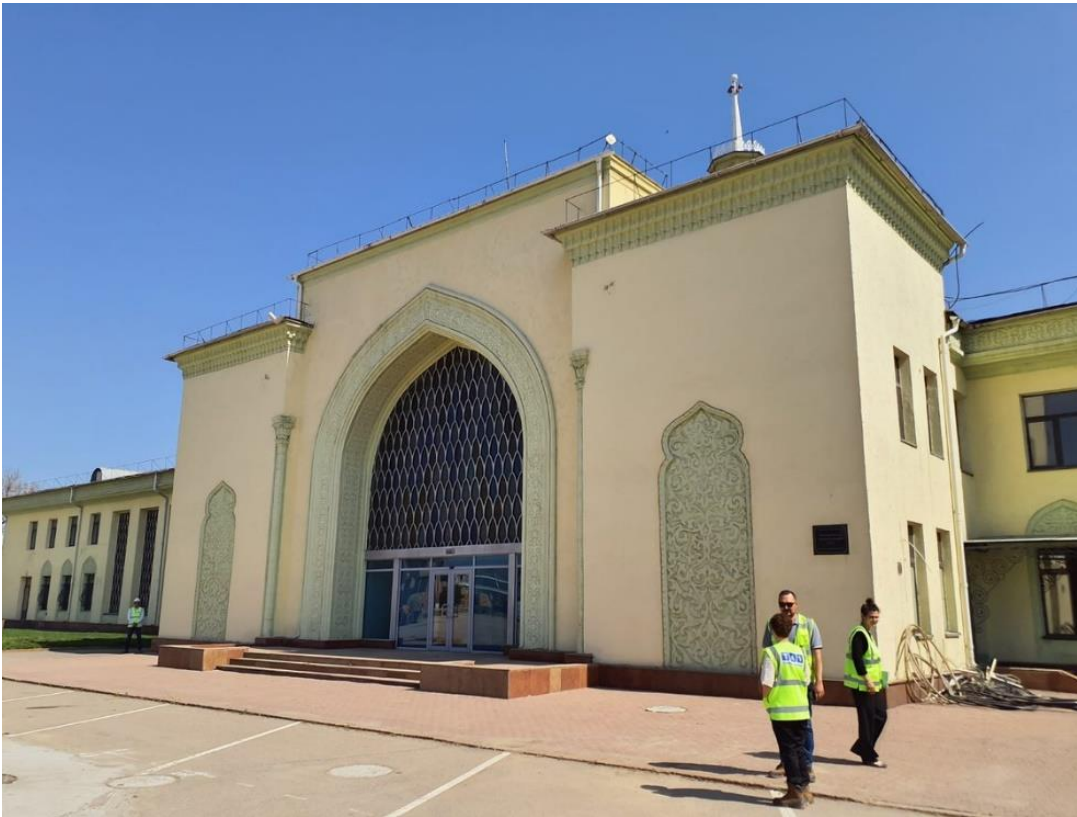
The western façade of the central block is dominated by the main entrance in the form of a substantial Central Asian pishtaq portal with a high pointed arch edged with a decorative stringcourse (Figure 5.10). The archway is filled with stained-glass, in a design inspired by panjara patterns of traditional carved window tracery of Central Asian buildings. These utilise blue, yellow and white pressed glass in a decorated 'flame' pattern that is repeated in all windows. The walls in the interior of the arch are decorated with arched niches with embossed floral ornamental patterns and decorative floral corner columns. The central part of the building is highlighted by a high cornice of two rows of stylized stalactites.

**Figure 5.10: The pishtaq of the central block viewed from the south-west**

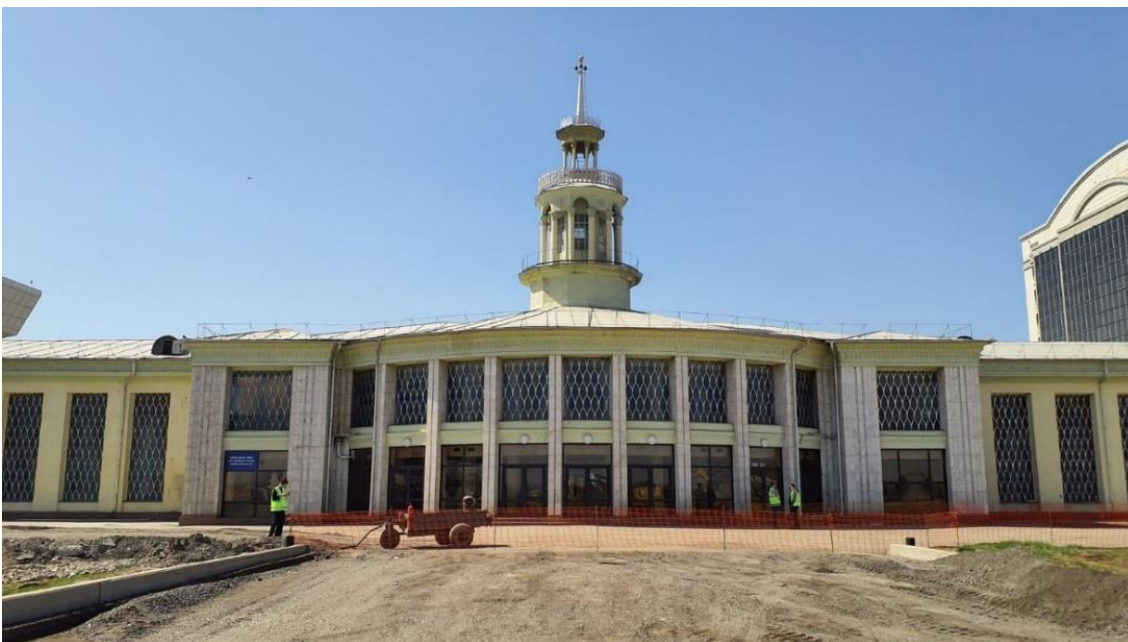
The eastern façade of the central block is apsidal with bays divided by engaged columns of marble cladding and historically formed a loggia (Figure 5.11 below). The space between the columns is filled with stained glass on the ground floor and stained glass and mosaic on the first floor. The pattern of the stained glass is the same as in the arch of the main western façade.

**Figure 5.11: The central block of the VIP Terminal Building viewed from the east**

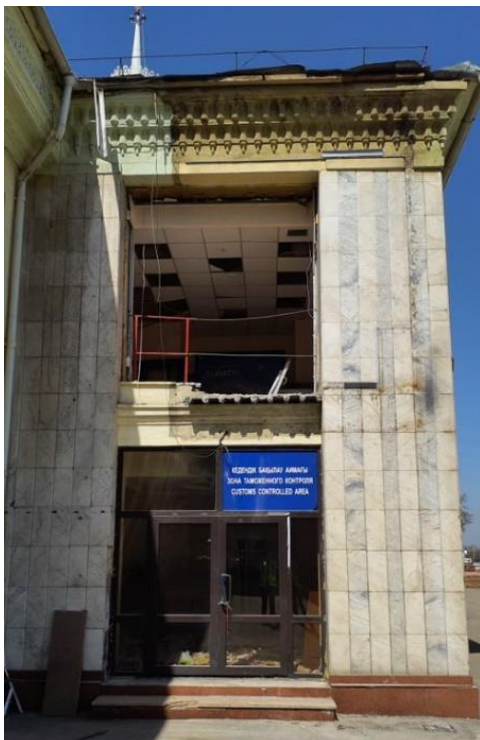
The loggia on the eastern façade was probably removed as part of this renovation of the building as seen in Figure 5.12 below. It was replaced with simple marble cladding. The central

**Figure 5.12: Marble cladding on the former loggia of the eastern facade of the Building**

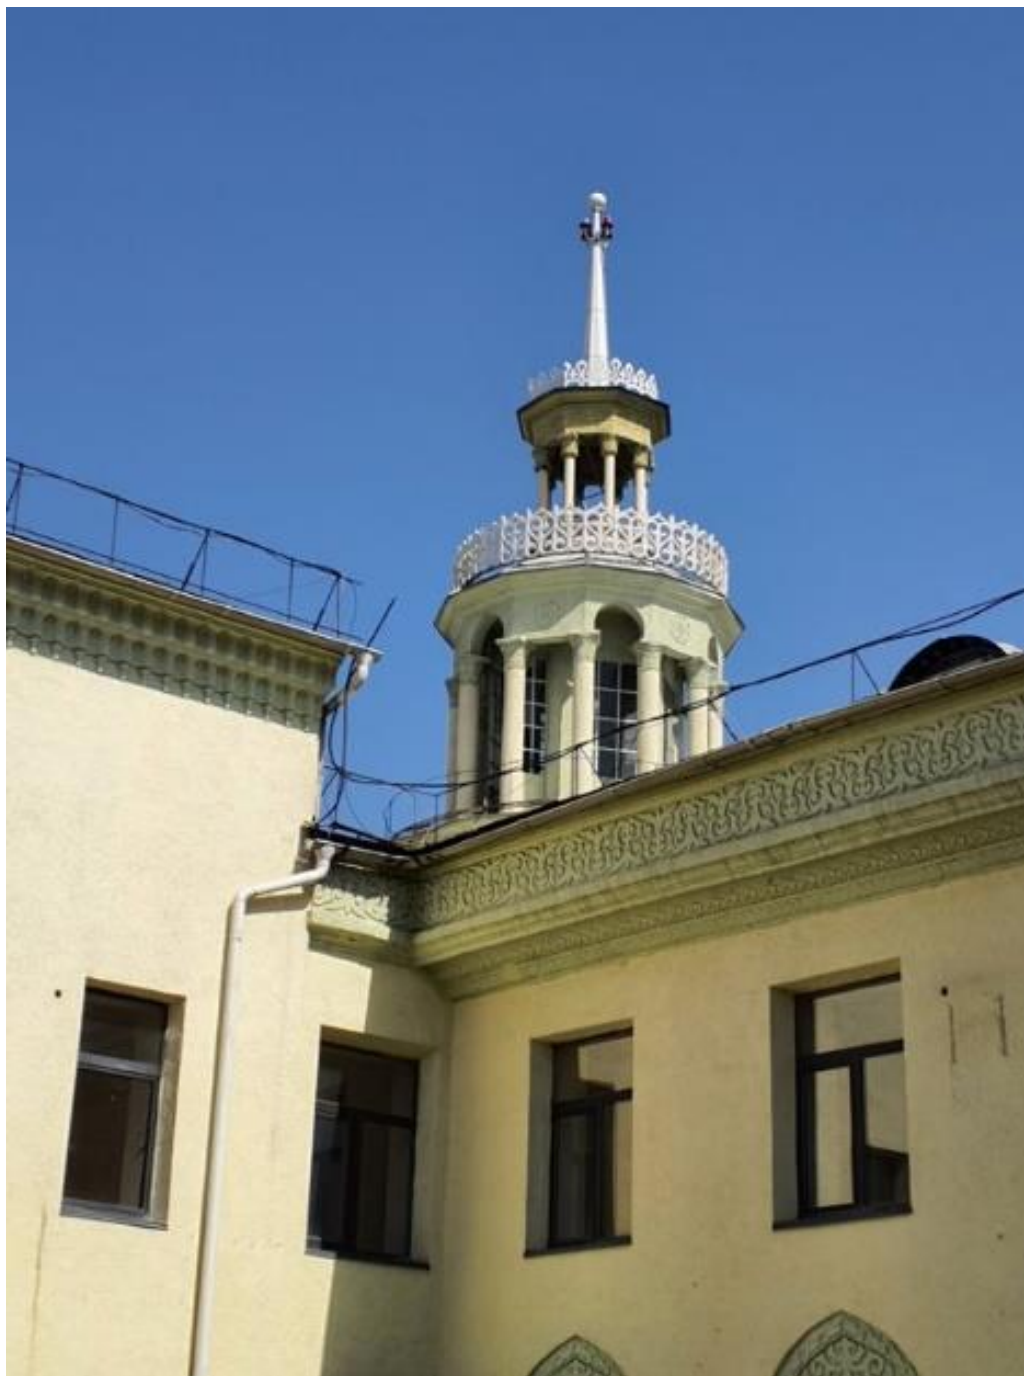
**Figure 5.13: The belvedere which surmounts the central block**

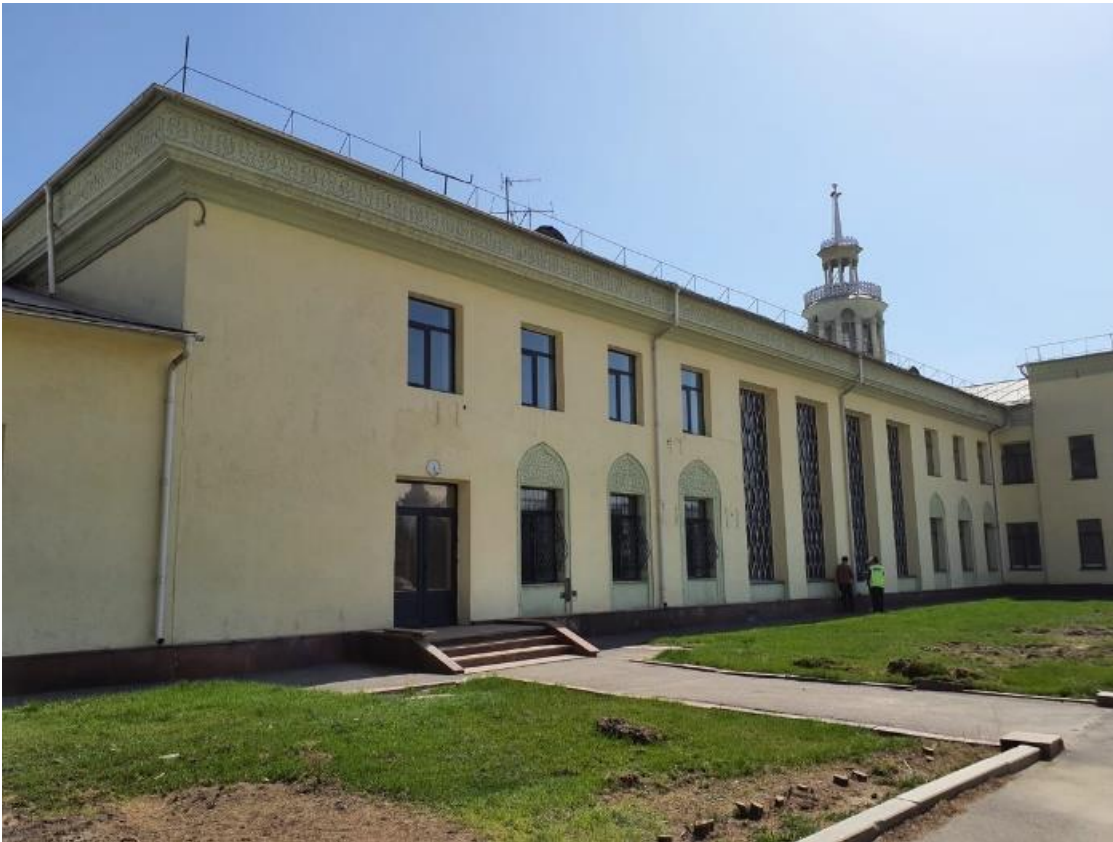
The facades of the flanking wings are decorated with relief cast cement cornices and window architraves with tympanums in the form of arched niches, decorated with patterns inspired by traditional Kazakh embroidery patterns and historical architecture of Kazakhstan and Central Asia (Figure 5.14). Higher window openings of double-height halls are filled with stained-glass of the same design and pattern as those of the central block.

**Figure 5.14: The western elevation of the northern flanking wing**

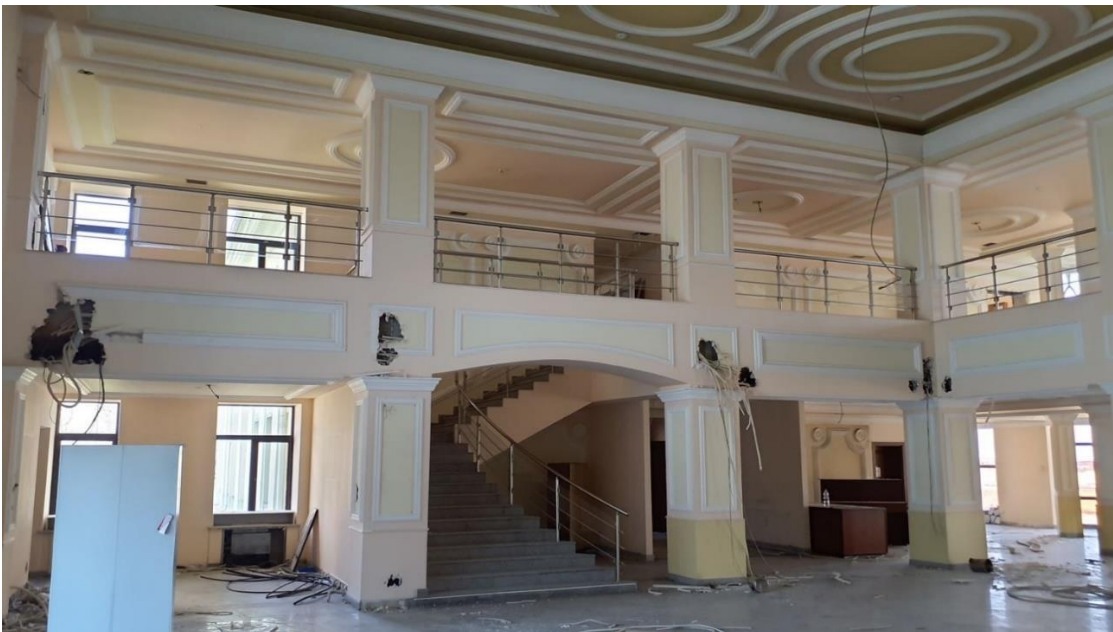
The interiors walls and ceilings inside are generally sheathed with plasterboard fixed to metal studs. The plasterboard is covered with stuccos in the form of mouldings, rosettes and cornices. The surfaces are coated with acrylic paints in a peach colour with white for dressings with yellow panels (Figure 5.15 below). The ceiling of the lobby is covered with geometric reliefs on gypsum panels edged with plaster mouldings with floral relief ornament. Floors are finished with marble and travertine tiles and mosaics.

**Figure 5.15: The interior of the lobby in the central block showing the current decorative scheme**

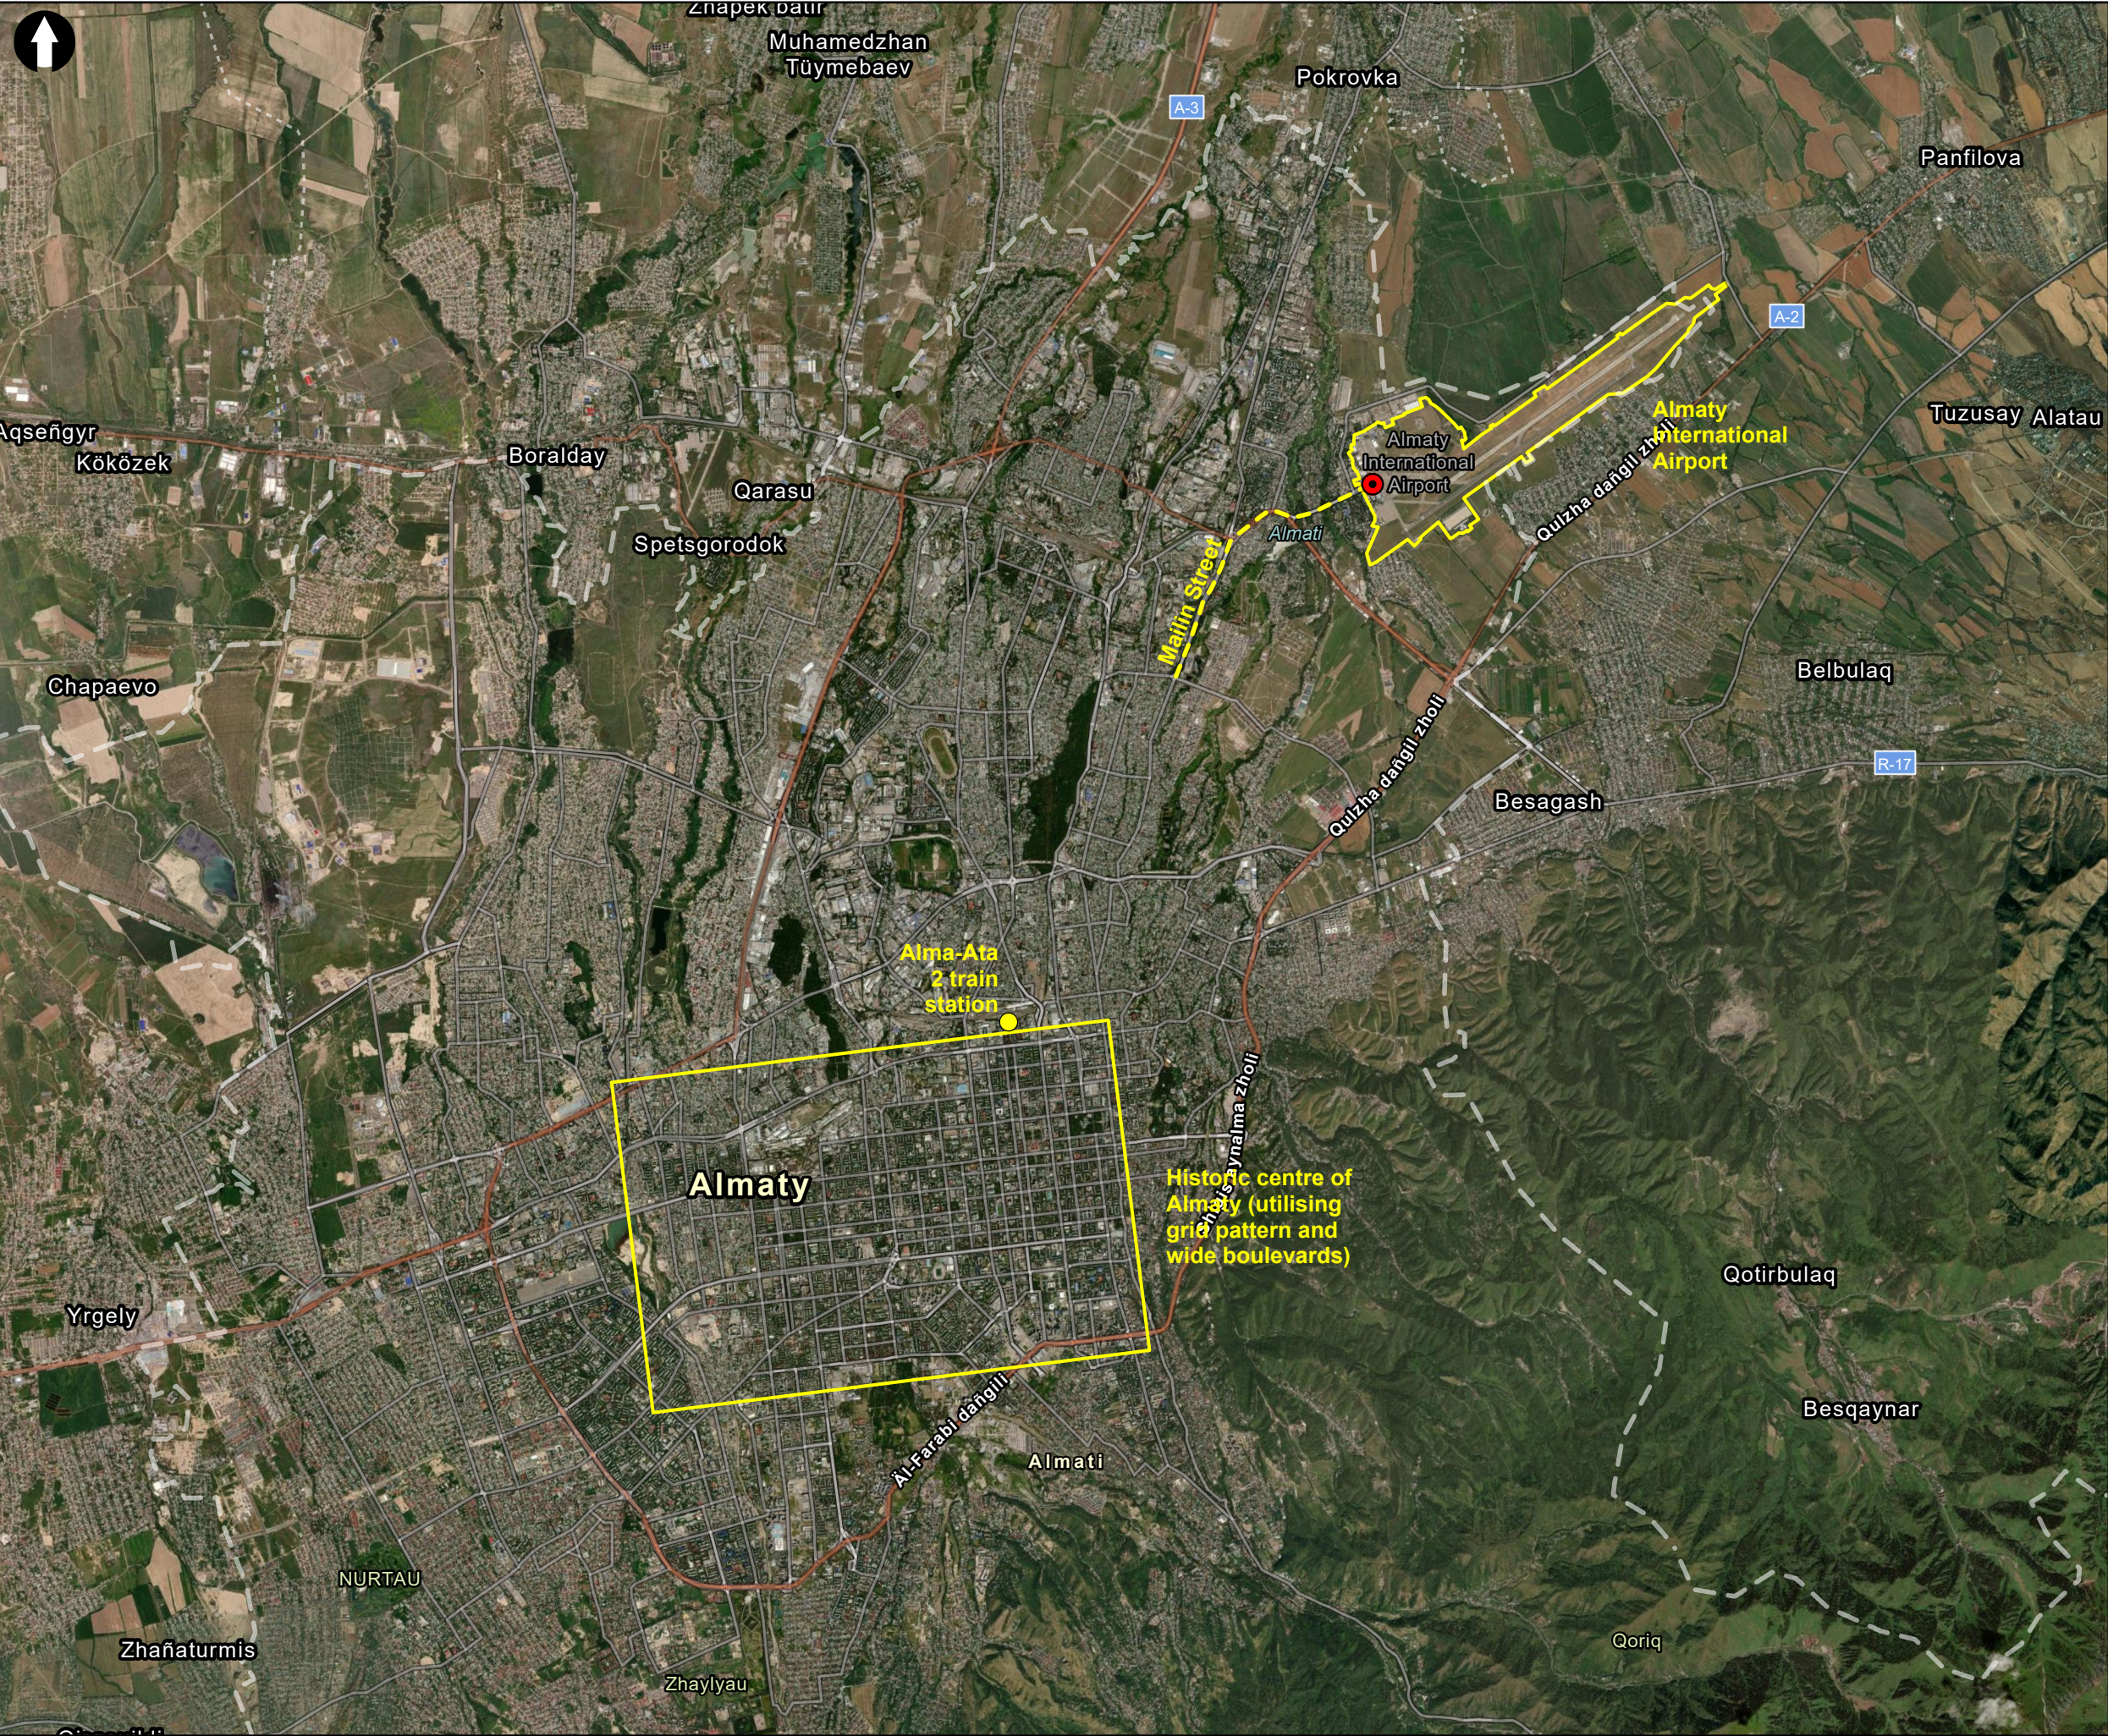
**Figure 8.1 - 100107121-MMD-00-XX-GIS-Y-0011 Almaty Airport Expansion Heritage Statement Historical Context of Almaty International Airport VIP Building: Almaty**

Almaty International Airport existing
	VIP terminal building
	Mailin Street

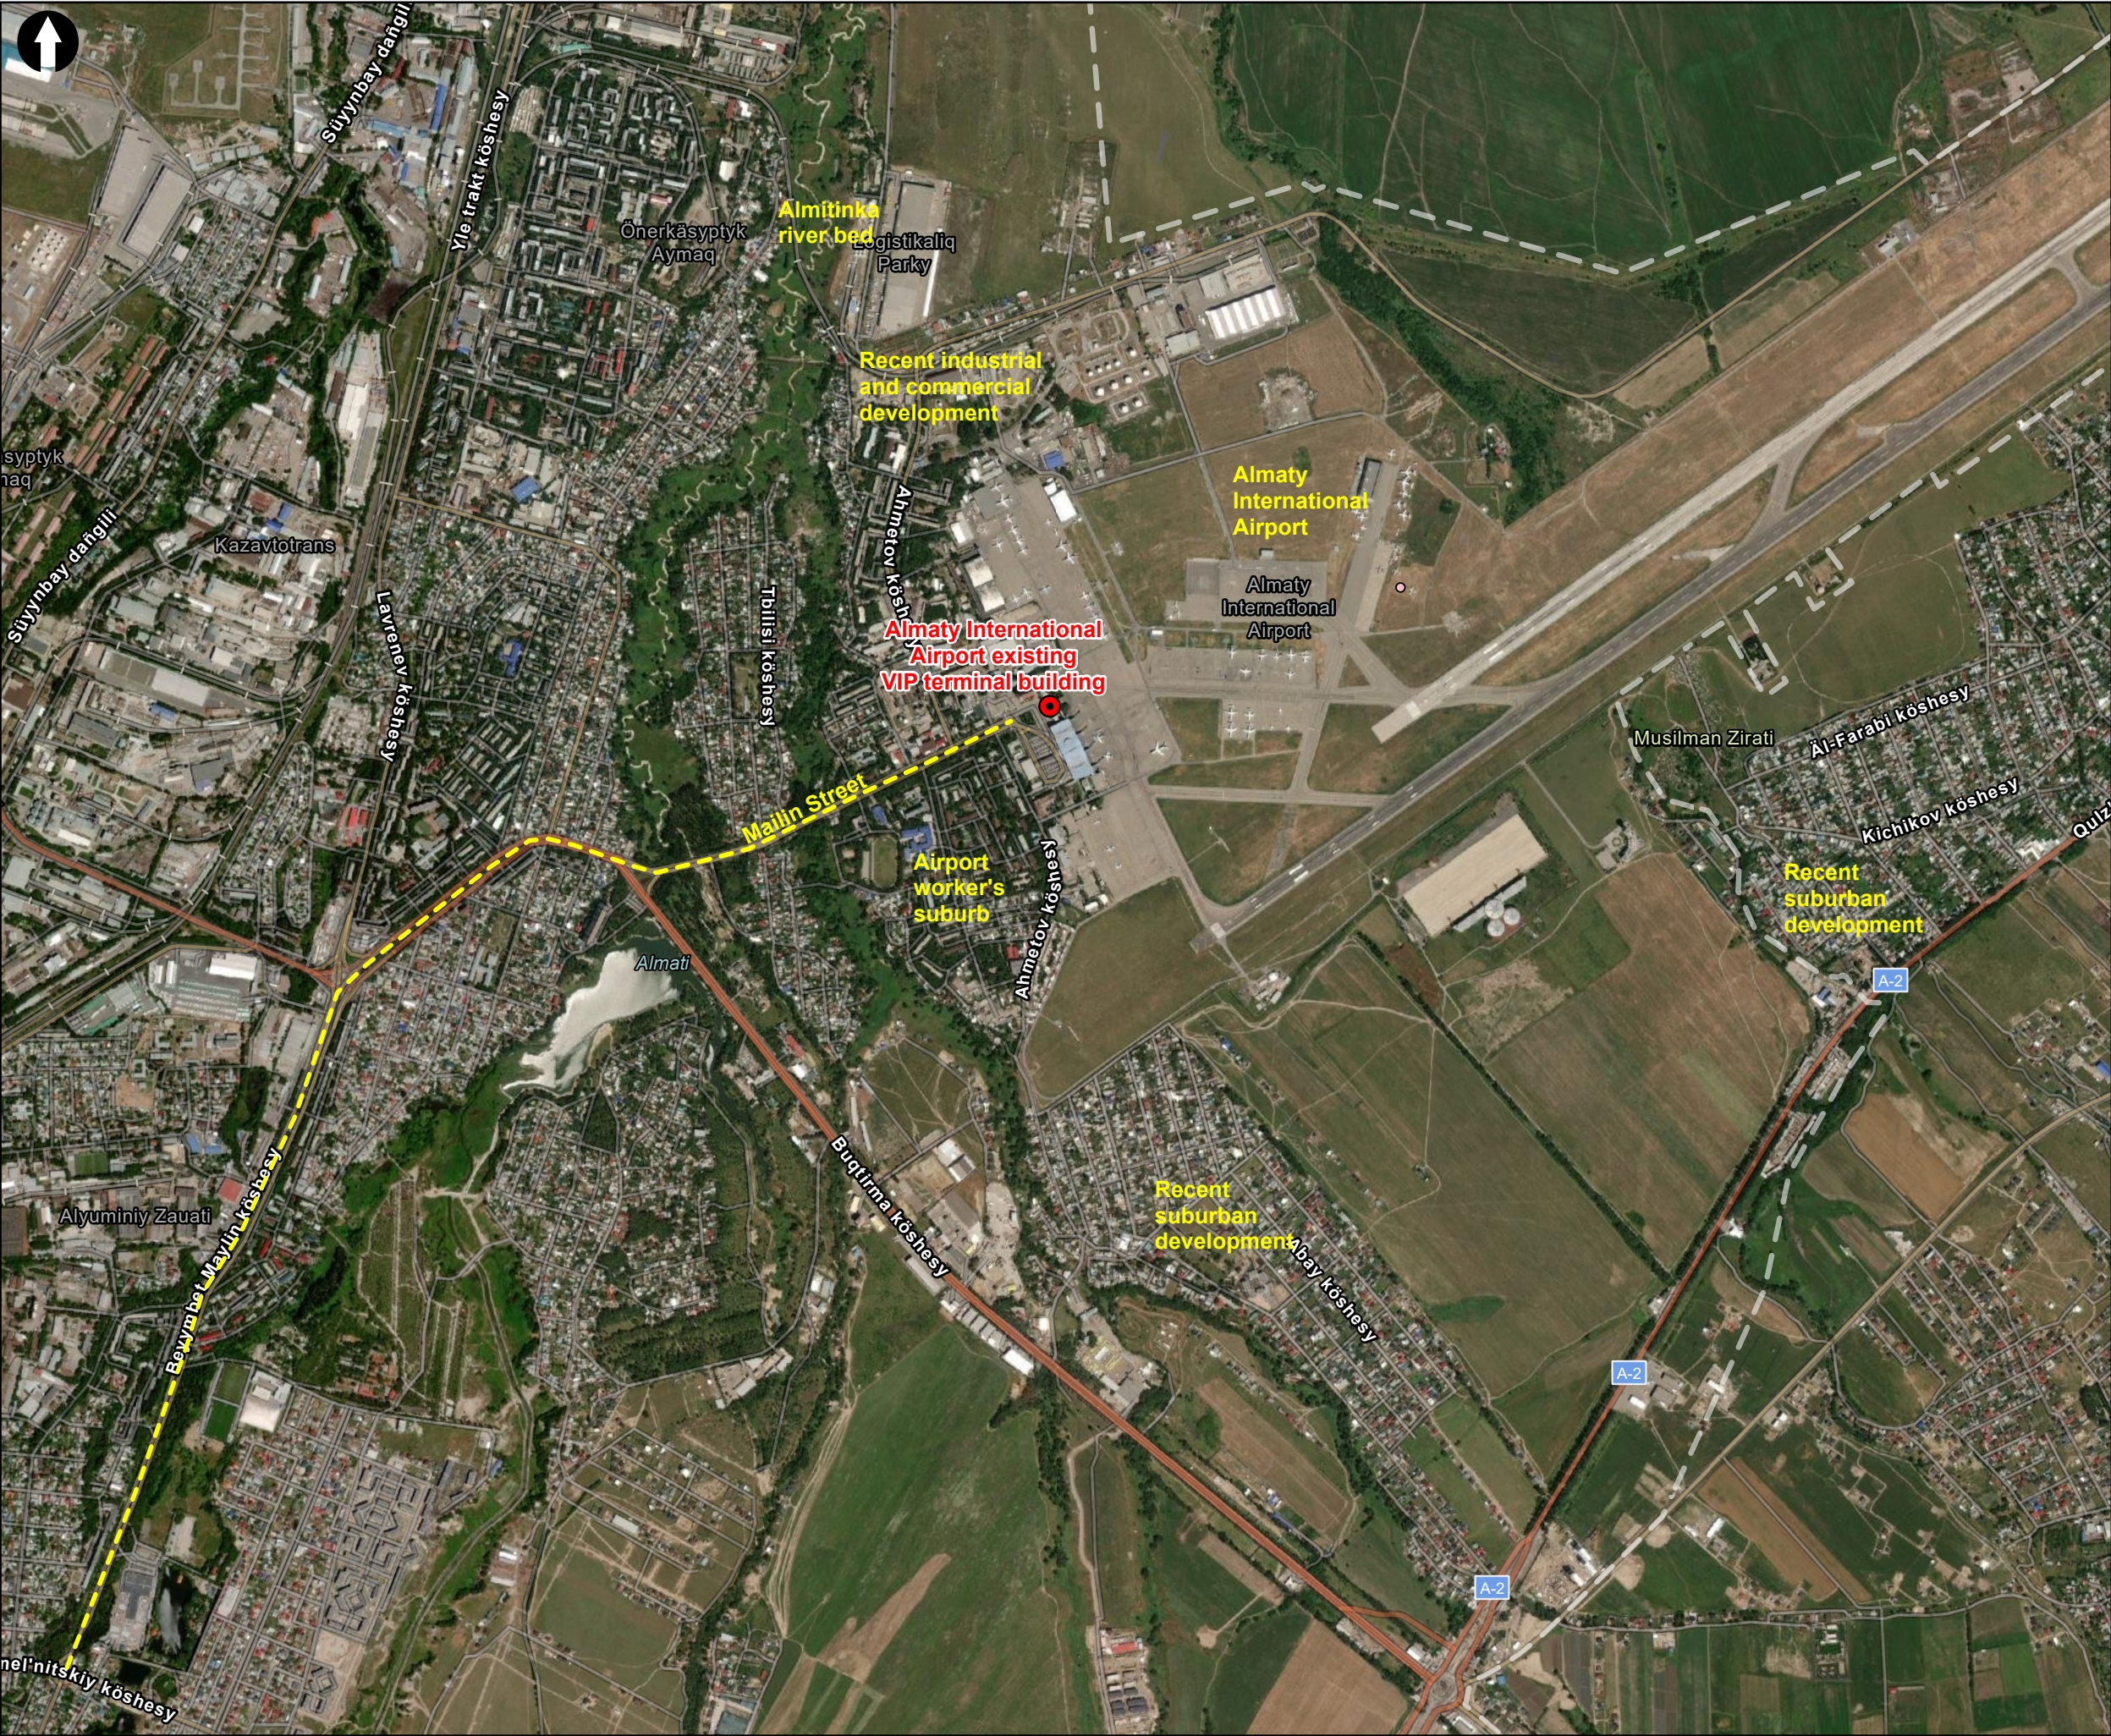
**Figure 8.2 - 100107121-MMD-00-XX-GIS-Y-0012 Almaty Airport Expansion Heritage Statement Historical Context of Almaty International Airport VIP Building: Almaty International Airport**

- Almaty International Airport existing VIP terminal building
- Mailın Street

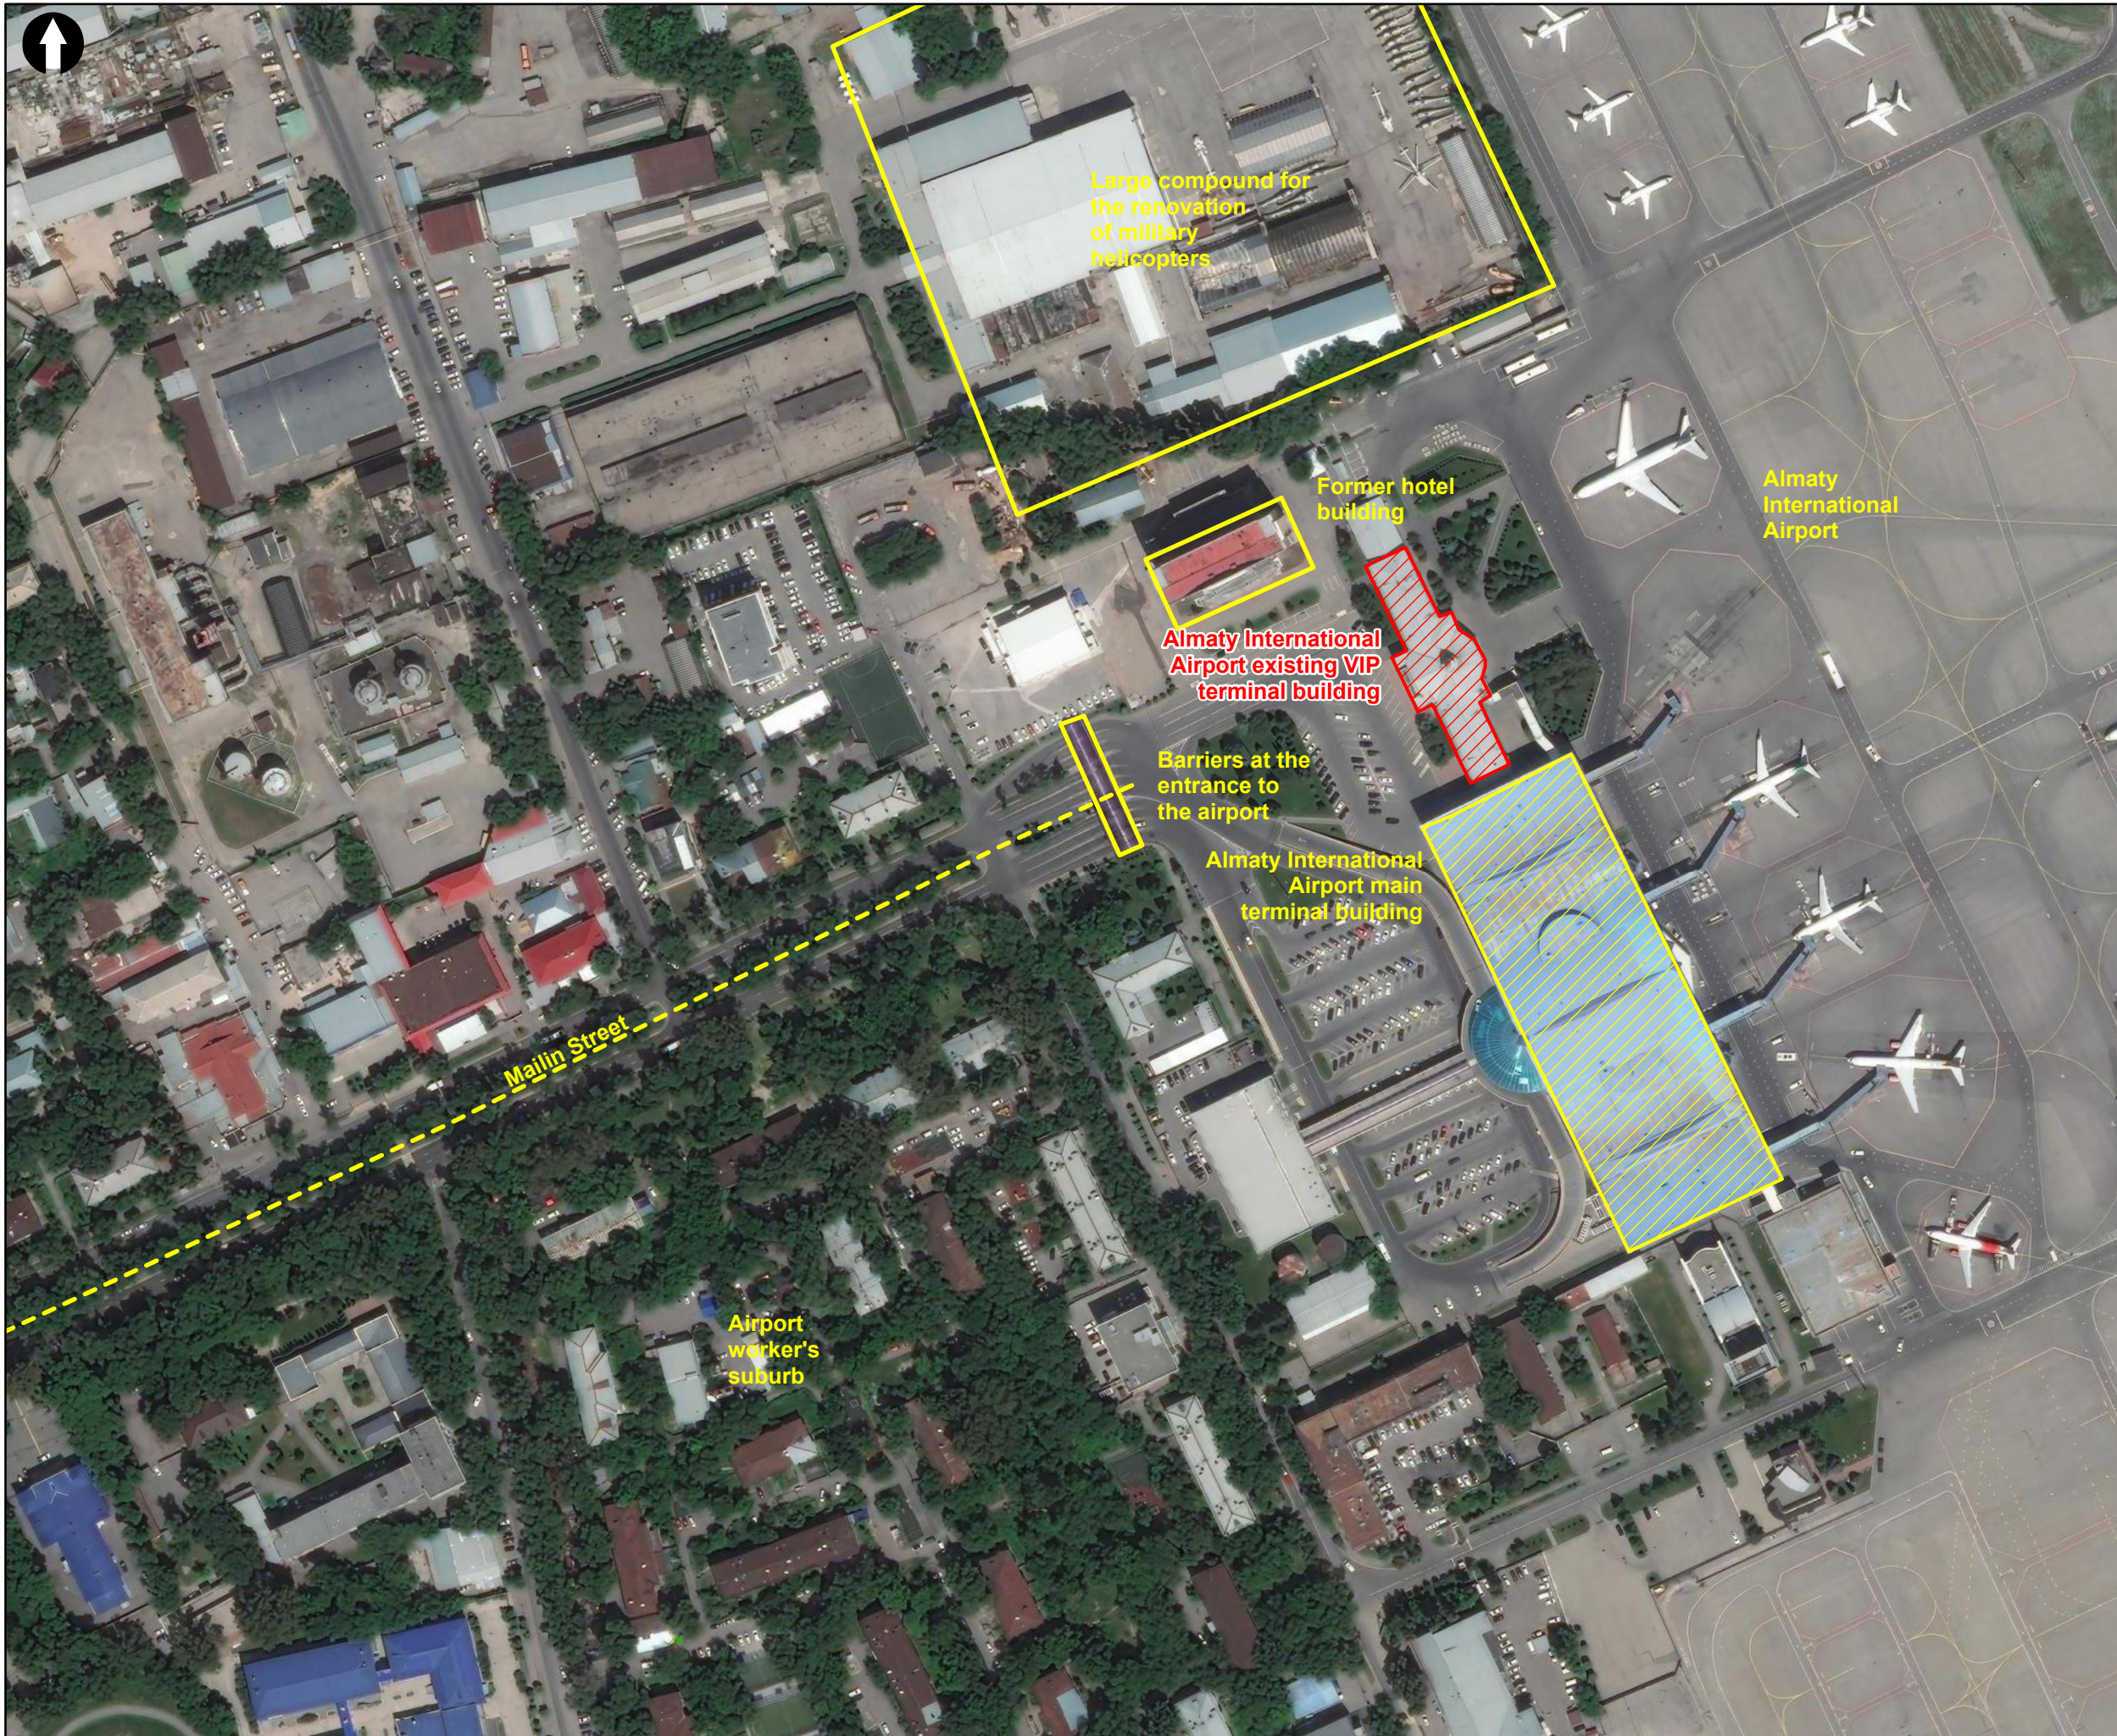
**Figure 8.3 - 100107121-MMD-00-XX-GIS-Y-0013 Almaty Airport Expansion Heritage Statement Historical Context of Almaty International Airport VIP Building: Mailin Street**

Almaty International Airport existing VIP terminal building
	Recent developments of Almaty International Airport
	Mailin Street

The Building represents one part of an evolving landscape that includes the airport runway, other airport buildings, Mailin Street and the airport worker's suburb. Within the airport and surrounding area elements of the historic spatial elements of the landscape survive but have become degraded. The development of Almaty Airport represents an opportunity to recover degraded spatial elements including the Mailin Street approach and enhance the cultural significance of the historic landscape.
