# **Almaty Airport Expansion - VIP Terminal Building**

Significant Fabric Assessment

June 2022

TAV Airport Holdings Co.

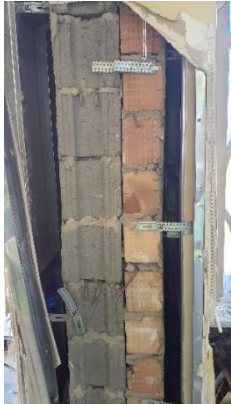
2	Structural element: Brickwork of walls and partition between concrete frame.	Authentic The external elements of the brickwork are of simple construction. They are part of the 1947 historic fabric and survive.	Brickwork infill is a material commonly used in modern construction. Although original historic fabric, it is ubiquitous to modern construction. Equally the fabric is not currently visible and does not contribute to the appearance of the building. Therefore, this element of fabric does not contribute to the cultural significance of the building.	None The brickwork of the walls and partition does not contribute to its cultural significance.	Good – the original brickwork survives and is in good condition with little obvious signs of defects, damage or decay. When exposed for assessment it is clear that the brickwork is however of relatively poor quality and reflects nature of the brick as infill which does not perform a structural role, nor a visible part of the building.

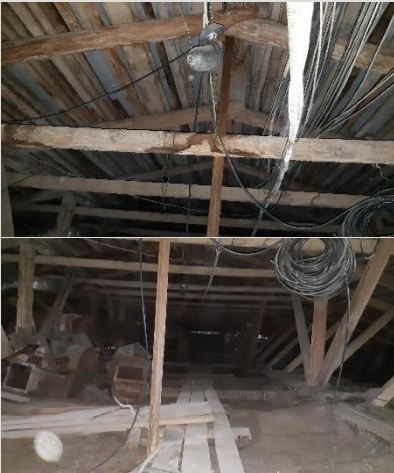
ID	Description	Statement of Authenticity	Statement of cultural significance	Degree of cultural significance	Condition	Photograph
3	Structural element: Timber roof truss structures	<p>Authentic</p> <p>These structural elements located within the roof space are part of the 1947 historic fabric and survive.</p>	<p>The timber roof truss structures are of scientific value as they illustrate the nature of materials available and construction techniques used during the period. Therefore, they do offer some contribution to the cultural significance of the building.</p>	<p>Low</p> <p>The timber roof truss structure does contribute to the building's cultural significance, however given the limited impact this element of the fabric has the on the way in which the building is experienced, and the relatively low quality of materials and techniques used, the contribution to the cultural significance of the building is limited.</p>	<p>Fair – the timber roof trusses survive in fair condition but have required significant additional supportive measures to be inserted in the past to ensure their structural stability.</p>

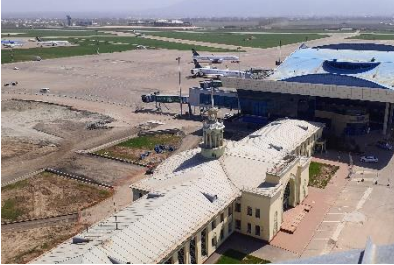
4	Structural element: Roof covering of galvanized sheet steel with folded joints on timber battens.	<p>Inauthentic</p> <p>The roof covering is similar to the original but has almost certainly been replaced, probably during renovation in 2008.</p>	<p>The roof covering does not contribute to the cultural significance of the asset as galvanized sheet steel used is a commonly used material and likely represents the replacement of earlier sheet metal coverings.</p>	<p>None</p> <p>The roof covering does not contribute to its cultural significance.</p>	<p>Fair – the roof covering survives in a fair condition, though this type of material is typically renewed periodically.</p>

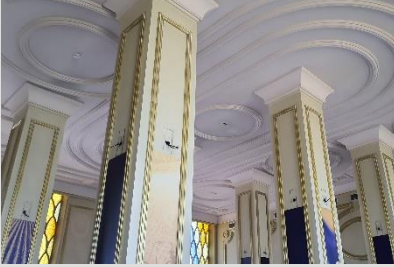
5	Structural element: Concrete columns of the building	<p>Partially authentic/ inauthentic</p> <p>The concrete columns located internally within the building which support the roof structure are original and survive. However, the decoration around</p>	<p>The columns form part of the structural framework of the building's original fabric. The locations of columns, while part of the structural concrete frame of the building have been incorporated into the design and layout of the interior spaces since the original construction of the building. The distribution of the columns is likely to be unchanged and contributes to the</p>	<p>Low</p> <p>The concrete columns are of low significance to the building. However, their distribution reflects the original structural design of the building and hence offer a limited contribution to the ability to understand the significance of the building.</p>	<p>Fair – where exposed behind the 2000 plasterboard covering, the columns have been shown to be in moderate condition.</p>

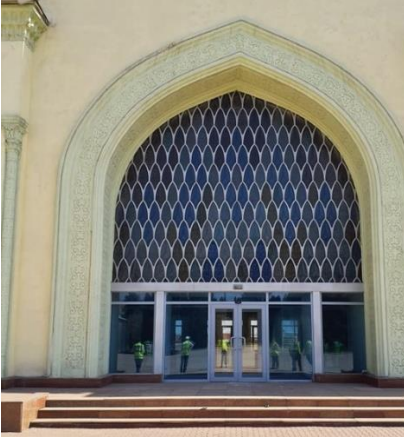
ID	Description	Statement of Authenticity	Statement of cultural significance	Degree of cultural significance	Condition	Photograph
6	Exterior: Pishtaq (Western elevation)	<p>Authentic</p> <p>The pishtaq is an original element of the 1947 design. See below for decorative elements.</p>	<p>historic value and cultural significance of the building.</p> <p>The pishtaq provides social value as a Central Asian style architectural feature which is of importance locally and regionally. The use of the regional architectural style in what is otherwise a Stalinist style building represents a recontextualization of local traditions in Soviet architecture and provides evidence of the treatment of regional identities within the Soviet Union during the period. The pishtaq is also a striking feature which granted the building landmark status and defines the relationship between the building and its spatial context. The pishtaq is considered to be of historic, aesthetic and social value and contributes to the cultural significance of the building. This is however derived from the form, and appearance of the feature and not from the materials from which the structure is constructed.</p> <p>See the Heritage Interpretation Plan (report 003).</p>	<p>High</p> <p>Given the illustration of historical treatment of regional culture and identity within the Soviet Union, the landmark status of the pishtaq, and the strong contribution to the way in which the building is experienced from its spatial context, the pishtaq is considered to be of high cultural significance. Significance is reinforced by the engaged Corinthian columns being two of very few (if not the only surviving examples) of their type on the building after the transformation of the loggia on the runway side</p>	<p>Good – the external façade and structure of the pishtaq survives in good condition with little obvious signs of defects, damage or decay.</p>

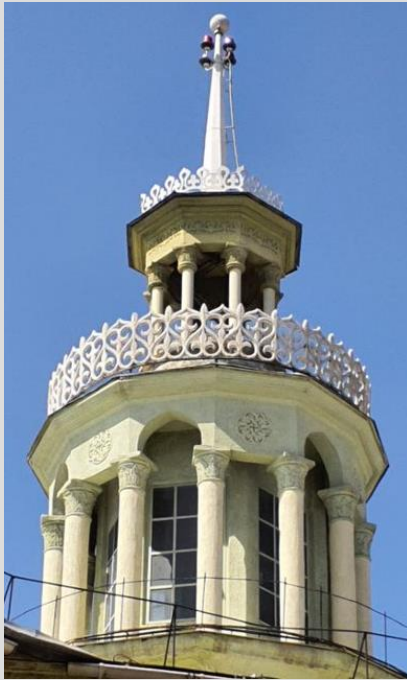
ID	Description	Statement of Authenticity	Statement of cultural significance	Degree of cultural significance	Condition	Photograph
7	Exterior: Belvedere	<p>Authentic</p> <p>The belvedere is an original element of the 1947 design. Some alteration and loss of specific features including the parapet visible on historic photos.</p>	<p>The belvedere is a typical feature of Soviet transport terminals during the period and demarcated the building as an airport terminal. The belvedere is also a typical feature of Stalinist buildings which drew heavily on neo-classical architectural motifs, while the later incorporation of regional architectural embellishment is evidence of the recontextualization of local traditions in Soviet architecture. Given the dominance of the feature, which serves as a local landmark and the way in which it was designed to define the relationship between the building and its spatial context contributes to both its historic and social value of the building. The belvedere is also of aesthetic value, which is derived from an appreciation of the decorative qualities of the feature. These values contribute to the cultural significance of the building. This is however derived from the form, and appearance of the feature and not from the materials from which the structure is constructed.</p> <p>See the Heritage Interpretation Plan (report 003).</p>	<p>High</p> <p>Given the contribution of the belvedere to the ability to appreciate the original design intent of the building, the influence of Soviet building 'types' on that design, and the way in which the feature defines the way in which the building is experienced from its spatial context, the belvedere is considered to be of high cultural significance. Significance is reinforced by its decorative cast cement balustrading/eaves cresting being the only surviving intact examples of their type left on the building</p>	<p>Poor – the belvedere is reported to be in a deteriorated state and suffering from structural instability owing to decay of timber elements and the breakup of cast cement ornamentation.</p>

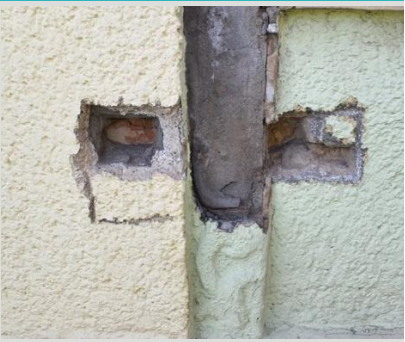
9	Exterior: Cement render over top of historical façade with marble chippings	Inauthentic Not original	The current render is modern and does not represent historic fabric. The current render is also considered as detrimental to cultural significance of the building as it has altered the exterior appearance of the building which would have had a smooth cement render, more sympathetic to the character and appearance of the structure. The render has also reduced the definition of some areas of façade decoration. The render therefore diminished the ability to understand the cultural significance of the building.	Intrusive The render has negatively impacted the Building by altering the historical appearance of the façade and diminishing the definition of decorations.	Good - the render over the façade decoration survives in a good condition with little obvious signs of defects, damage or decay.

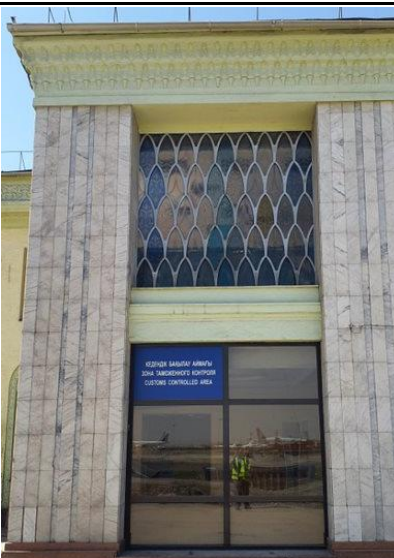
ID	Description	Statement of Authenticity	Statement of cultural significance	Degree of cultural significance	Condition	Photograph
10	Exterior: Marble cladding of the columns of the eastern façade of the central block.	Inauthentic Not original. The marble cladding represents an infill of the former engaged Corinthian style columns of the loggia on the eastern façade, in 1975. It survives.	The marble cladding represents an infill of the former engaged Corinthian style columns of the loggia on the eastern façade, dated to 1975 when the interior was extended into the space of the loggia. While the marble cladding illustrates the historic development of the building over time, and the adaptation of the interior spaces, the cladding has resulted in a detrimental effect on the ability to appreciate the overt neo-classical influences on the facade facing onto the airport space. This use of the European influenced neo-classical Stalinist style was used to define the boundary between the airport space in the east and the public realm to the west, which was dominated by Central Asian style features. It is also considered that the cladding is unsympathetic to the prevailing decorative features of the building which are constructed of cast cement. Overall, the marble cladding has had a detrimental effect upon the ability to appreciate the cultural significance of the building.	Intrusive The marble cladding detrimentally effects the ability to appreciate the cultural significance of the building, representing an unsympathetic later addition which resulted in the loss of original fabric.	Fair – the marble cladding survives in a fair condition, with some staining at the tops of marble panels.

A photograph showing the exterior of a building facade. It features two large, light-colored marble-clad columns flanking a window. The window is covered with a decorative, diamond-patterned metal grille. Below the window is a glass entrance with a blue sign that reads "КЕЛІМІСІЗ БАШҚАУ АЯМАҒЫ" and "CUSTOMS CONTROLLED AREA". The building has a neo-classical or Stalinist architectural style.

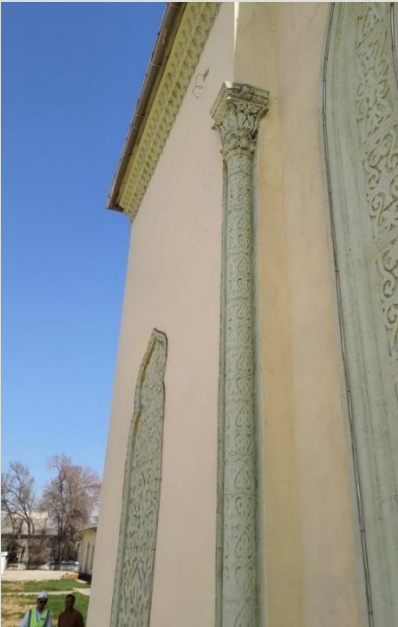
ID	Description	Statement of Authenticity	Statement of cultural significance	Degree of cultural significance	Condition	Photograph
11	<p>Exterior: Cast cement relief decorative panels, cornices and ornamental relief and engaged columns.</p>	<p>Authentic These are original elements of the 1947 design and survive.</p>	<p>The cast cement reliefs reflect an early South Kazakh architectural style including decorative motifs which have been influenced by much earlier Timurid architectural styles. The use of regional architectural styles in what is otherwise a Stalinist style building represents a recontextualization of local traditions in Soviet architecture and provides evidence of the treatment of regional identities within the Soviet Union during the period. As well as the aesthetic value, derived from an appreciation of the decorative qualities of these elements of the building's fabric, these elements are also of historic and social value which contributes to the cultural significance of the VIP Terminal Building.  See the Heritage Interpretation Plan (report 003).</p>	<p>High Given the illustration of historical treatment of regional culture and identity within the Soviet Union which is of both historic and social value, as well as the aesthetic value, derived from an appreciation of their decorative qualities, cast cement reliefs are considered to be of high cultural significance.</p>	<p>Good – cast cement relief decorative panels, cornices and ornamental relief and engaged columns survive in a good condition with little obvious signs of defects, damage or decay</p>

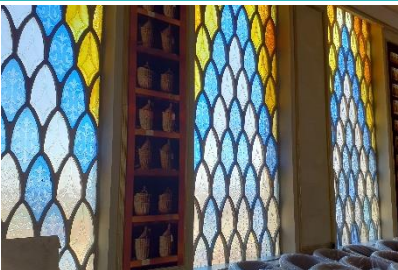
12	<p>Exterior: Artistic stained glass panels</p>	<p>Inauthentic Not original. Artistic stained glass installed in 1975. Survives.</p>	<p>Artistic stained glass panels are present above the central doorway within the pishtaq and full height windows. The stained glass was installed in 1975 and made to the designs of the artist V. Senchenko, utilising traditional Central Asian panjara window tracery with ethnic ornaments and kerege patterns which reflect the traditional latticework of the Kazakh yurt.  These panels reflect a recontextualization of local traditions in Soviet architecture and provides evidence of the treatment of regional</p>	<p>High Given the illustration of historical treatment of regional culture and identity within the Soviet Union which is of both historic and social value, as well as the aesthetic value, derived from an appreciation of their decorative qualities, artistic stained glass panels are considered to be of high cultural significance.</p>	<p>Good – the stained glass is generally in good condition though will require repair as there is surface wear on the metal fasteners which hold individual pieces of glass in place.</p>

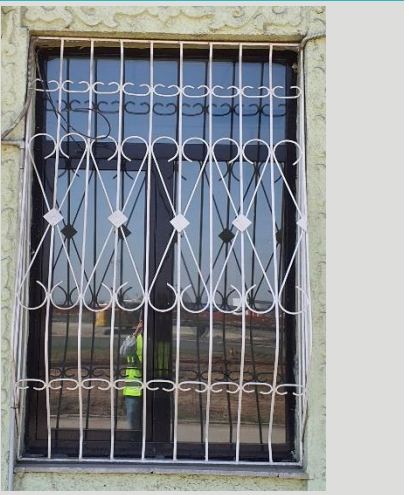
13	<p>Exterior:                      Window frames within original openings</p>	<p>Inauthentic                      Not original. They have replaced the original window frames throughout.</p>	<p>The window frames within the original openings have all been replaced. They are of recent aluminium and glass and are likely to have been added during the 2000s refurbishment. These do not contribute to the ability to understand the cultural significance of the VIP Terminal Building.</p>	<p>None                      The window frames within original openings do not contribute to the significance of the building</p>	<p>Good – the window frames within original openings survive in a good condition with little obvious signs of defects, damage or decay reflecting the refurbishment in the early 2000s.</p>

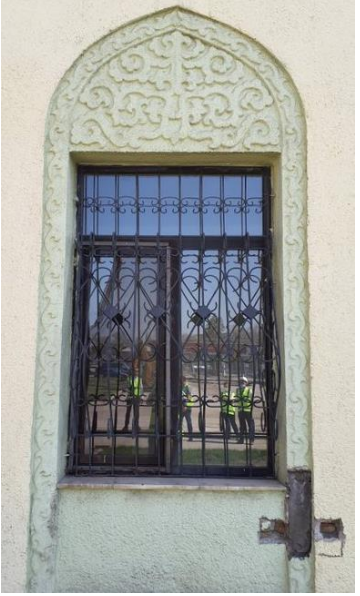
ID	Description	Statement of Authenticity	Statement of cultural significance	Degree of cultural significance	Condition	Photograph
14	Exterior: Windows openings and surrounds including decorative tympana	Inauthentic Not original. Addition of regional architectural motifs in 1957. Survives.	<p>The external window openings and surrounds reflect the historic layout of the building principal elevations, while the decorative surrounds including tympana reflect the addition of regional architectural motifs in 1957. The window openings and surrounds are considered to be of aesthetic value, which is derived from an appreciation of their contribution to the balanced composition of the building's facades, as well as the decorative qualities of these elements.</p> <p>The use of regional architectural styles in what is otherwise a Stalinist style building represents a recontextualization of local traditions in Soviet architecture and provides evidence of the treatment of regional identities within the USSR during the period. This contributes to the cultural significance of the building.</p>	Moderate Given the illustration of historical treatment of regional culture and identity within the USSR which is of both historic and social value, as well as the aesthetic value, derived from an appreciation of their decorative qualities, cast cement reliefs are considered to be of moderate cultural significance.	Good – external windows openings and surrounds including decorative tympana survive in a good condition with little obvious signs of defects, damage or decay

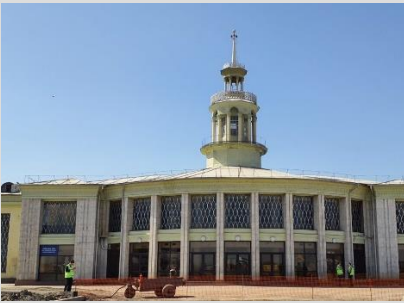
15	Exterior: Former loggia (eastern facade)	Inauthentic Not original. The former loggia comprises an apsidal projection in the centre of the eastern facade, where a loggia of Corinthian columns was once located. Does not survive. This has been replaced by a simpler marble design.	<p>The former loggia comprises an apsidal projection in the centre of the eastern facade, where a loggia of Corinthian columns was once located. The loss of the original loggia, and the extension of the interior space into the former loggia has resulted in the loss of original historic fabric and the loss of an overtly Stalinist style element of the building. This has diminished the ability to understand the juxtaposition between the Stalinist and regional styles employed across the building's facades, and how that defined the boundary between the airport and the public sphere beyond. These elements of the building's fabric have had a</p>	Intrusive The historic fabric of the former loggia has been largely altered. The former loggia would have had high significance, the alteration of this original feature has detrimentally affected the cultural significance of the building.	Fair – the former loggia survives survive in a good condition with little obvious signs of defects, damage or decay other than staining from faulty drainage goods and damage to the roof above.

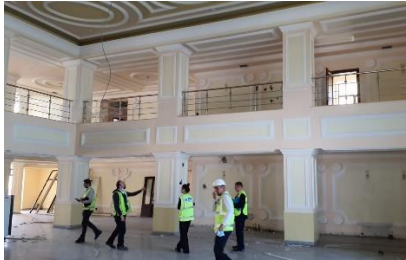
ID	Description	Statement of Authenticity	Statement of cultural significance	Degree of cultural significance	Condition	Photograph
16	Interior: Existing decorative stuccos on plasterboard sheathings of walls, columns, plasterboard ceilings (mouldings, rosettes, cornices, etc)	Inauthentic Not original. No original elements survive.	detrimental effect upon the ability to appreciate the cultural significance of the building. See the Heritage Interpretation Plan (report 003).  The interior plasterboard and stucco decorations within the building are associated with modern refurbishment of the interiors and do not contribute to the ability to understand the cultural significance of the Building. As all of these plasterboard and stucco covering has not been removed their remains the possibility that original features are hidden from view.	None Existing decorative stuccos on plasterboard sheathings of walls, columns, plasterboard ceilings do not contribute to the cultural significance of the building.	Good – existing decorative stuccos on plasterboard sheathings of walls, columns, plasterboard ceilings the decorative stuccos survive in a good condition with little obvious signs of defects, damage or decay reflecting the refurbishment in the early 2000s.

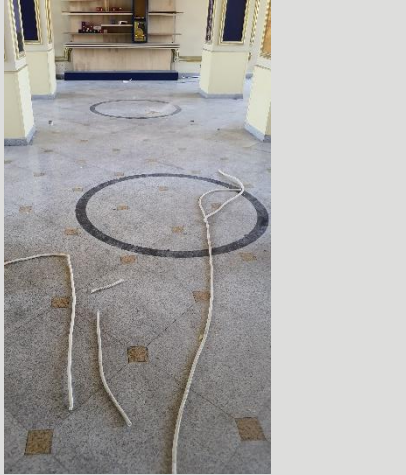
17	Interior: Stoneware floor coverings.	Inauthentic Not original. No original elements survive.	Stoneware floor coverings are associated with modern refurbishment of the interiors and do not contribute to the ability to understand the cultural significance of the Building.	None The stoneware floor coverings do not contribute to the cultural significance of the building.	Good – the stoneware floor coverings survive in a good condition with little obvious signs of defects, damage or decay reflecting the refurbishment in the early 2000s.

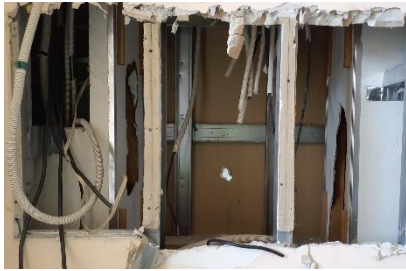
ID	Description	Statement of Authenticity	Statement of cultural significance	Degree of cultural significance	Condition	Photograph
18	Interior: Partition internal walls within the main block.	Inauthentic/ Partially authentic Not original. The internal partition walls are likely to have been extensively altered in the 2000s.	The internal partition walls are likely to have been extensively altered in the early 2000s. It is not clear what areas of the layout are original. These elements of the building may be able to provide evidence of the historic use of the interior spaces, and therefore are considered to offer a limited contribution to the ability to understand the cultural significance of the building.	Low Given the possible contribution to the understanding of past use of interior spaces, despite uncertain provenance of layouts, the contribution to the ability to understand the cultural significance of the building is low.	Good – partition internal walls within the main block survive in a good condition with little obvious signs of defects, damage or decay

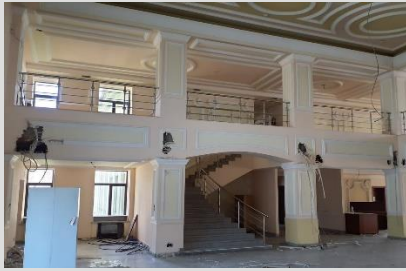
19	Interior: Staircases and balconies in the central atrium	Inauthentic/ Partially authentic Not original. The staircases and balconies in the central atrium have been extensively remodelled in the 2000s.	The staircases and balconies in the central atrium have been extensively remodelled in the early 2000s. The marble coverings of the stairwells is likely to date to this period. It is not clear whether the layout of this area is original, therefore it is considered these element of the building's fabric offer a limited contribution to the ability to understand the cultural significance of the building.	Low Given the loss of original finishes, and uncertain provenance of layouts the contribution to the ability to understand the cultural significance of the building is low.	Good – the stairwells and balconies of the central atrium survive in a good condition with little obvious signs of defects, damage or decay reflecting the refurbishment in the early 2000s.

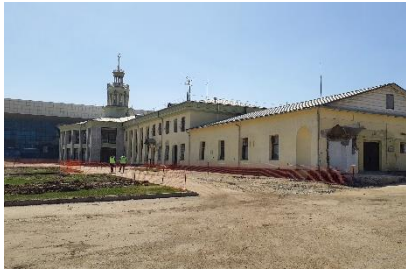
20	Northern annex	Inauthentic Not original. The northern annex represents a modern addition dating to 2008.	The northern annex represents a modern addition, attached to the northern elevation of the west wing of the building. This building unbalances the symmetrical appearance of the façade, and while of smaller scale and clearly subservient to the VIP Terminal Building, does diminish the ability to appreciate the design intent of the building to a limited extent. The annex therefore has resulted in a detrimental effect upon the cultural significance of the VIP Terminal Building.	Intrusive The building is a later additional, which altered the symmetry of the eastern and western façades.	Good – the northern annex survives in a good condition with little obvious signs of defects, damage or decay

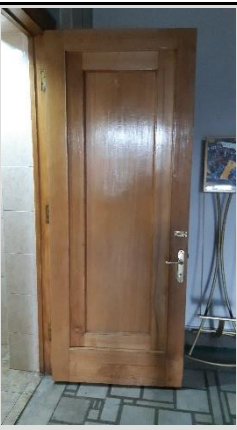
ID	Description	Statement of Authenticity	Statement of cultural significance	Degree of cultural significance	Condition	Photograph
21	Internal doors and other joinery	<p>Inauthentic</p> <p>Not original. The internal doors and joinery have been replaced. The majority of the surviving examples date to the 2000s.</p>	<p>The majority of internal doors were likely associated with modern refurbishment of the interiors and do not contribute to the ability to understand the cultural significance of the Building. This joinery has now largely been removed.</p>	<p>None</p> <p>The majority of Internal doors and other joinery do not survive, and likely represented modern replacement fittings</p>	<p>Very bad – the majority of internal doors and other joinery have been removed from the Building.</p>

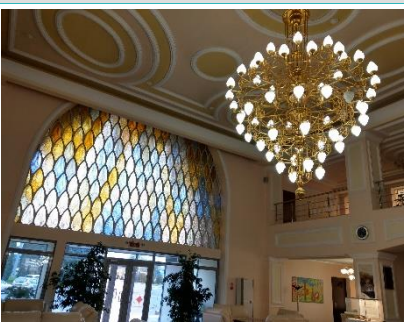
22	Light fittings	<p>Inauthentic</p> <p>Light fittings have been removed from the Building.</p>	<p>The former light fittings were part of the refurbishment in the 2000s. They have been removed. No light fittings survive in the Building.</p>	<p>None</p> <p>The light fittings do not survive, and represented modern replacement fittings.</p>	<p>Very bad – light fittings have been removed from the Building (photograph shows example prior to removal).</p>
